**FINAL SUMMARY REPORT OF
FUEL-DYNAMICS TESTS H2 AND E4**

ANL-76-16

Reactor Analysis and Safety Division

February 1976

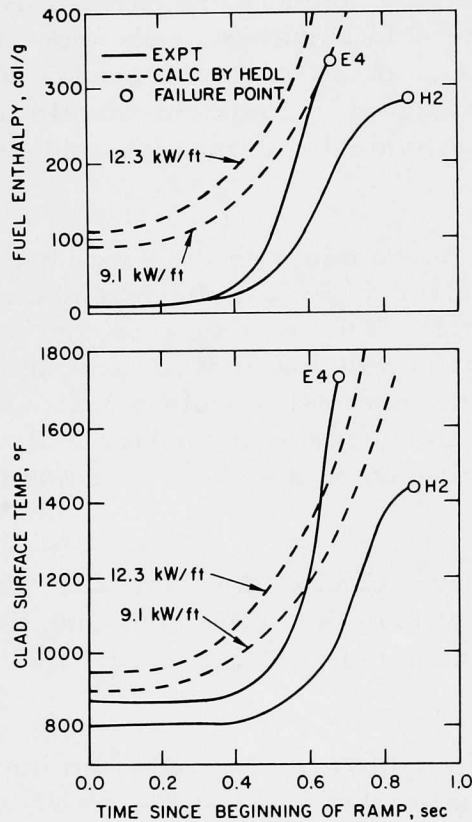
Fig. 1

HEDL has provided calculated fuel energy and cladding-temperature histories for a hypothetical \$3/sec unprotected transient overpower accident in FFTF.³³ Figure 1 compares these calculations for a high- (12.3 kW/ft) and a low-power pin (9.1 kW/ft) to those of the experiments. Conditions at the time of failure are reasonably prototypic, but the prefailure rates of change are more characteristic of \$6-10/sec accidents. Equilibrium conditions were being approached at the time of failure in Test H2 and, hence, it is characteristic of a scram-protected accident. Test E4 is clearly in the unprotected-accident class at the time of failure.

Thermal-history Comparison between Experiments and Calculated \$3/sec Unprotected TOP Accident in FFTF. Calculations were performed by HEDL.³³ Fuel enthalpy and cladding temperature for the experiments were calculated by the COBRA-III code using the measured test geometry and flow conditions, and the TREAT power as a driving function. "Zero" time for the experiments is taken as the time when the reactor power reaches 1 MW (see Figs. 4 and 5).

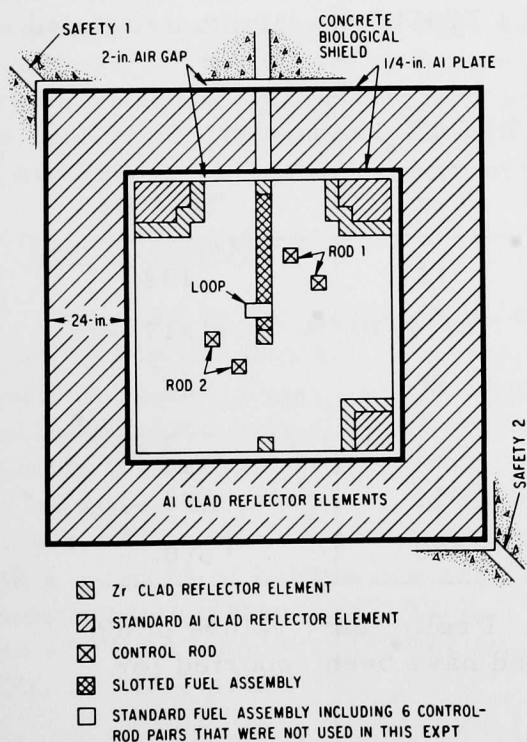
For Test H2 (Transient 1317, Loading 554), the 19 x 19-in. TREAT core array was loaded with 277 standard fuel elements, 16 control-rod elements, 9 slotted fuel elements, 2 slotted aluminum-clad reflector elements, 23 Zircaloy-clad reflector elements, and 32 aluminum-clad reflector elements, as shown in Fig. 2. Each TREAT control or transient rod shown in Fig. 2 consists of a pair of control elements driven as a single unit.

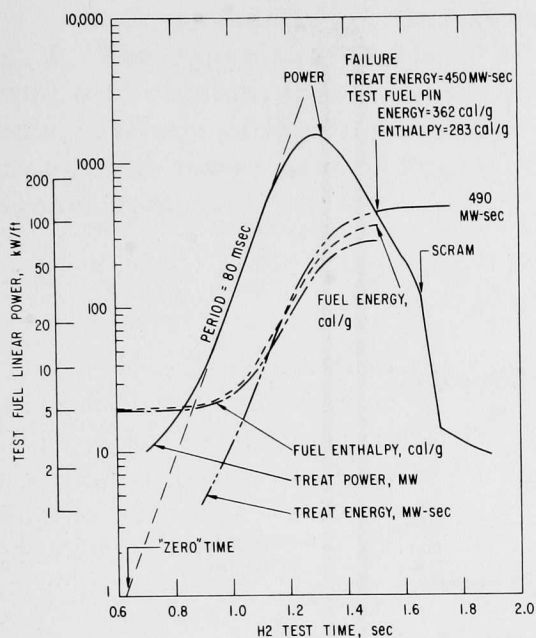
Fig. 4. Power and Energy History for Test H2. TREAT energy is the integral of the power, and fuel energy from fission is the product of the TREAT energy and the calibration factor. Test-fuel enthalpy was calculated by the COBRA-III code using the power history as a driving function. The left scale is the fuel power in kW/ft at the hottest axial node.

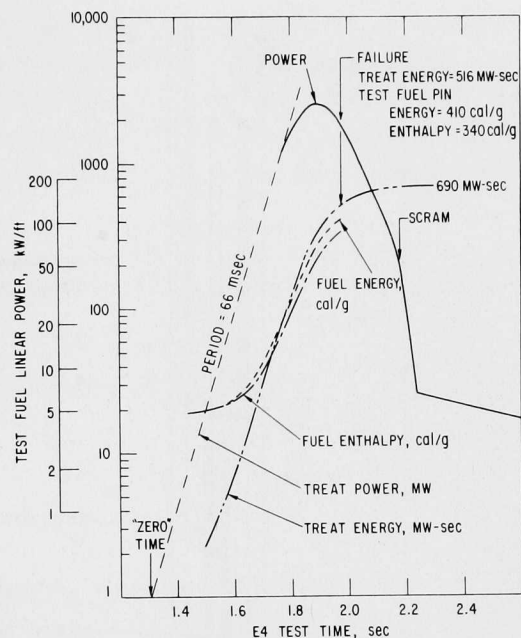
Fig. 5. Power and Energy History for Test E4. TREAT energy is the integral of the power, and fuel energy from fission is the product of the TREAT energy and the calibration factor. Test-fuel enthalpy was calculated by the COBRA-III code using the power history as a driving function. The scale on the right represents the test-fuel power in kW/ft at the hottest axial node.

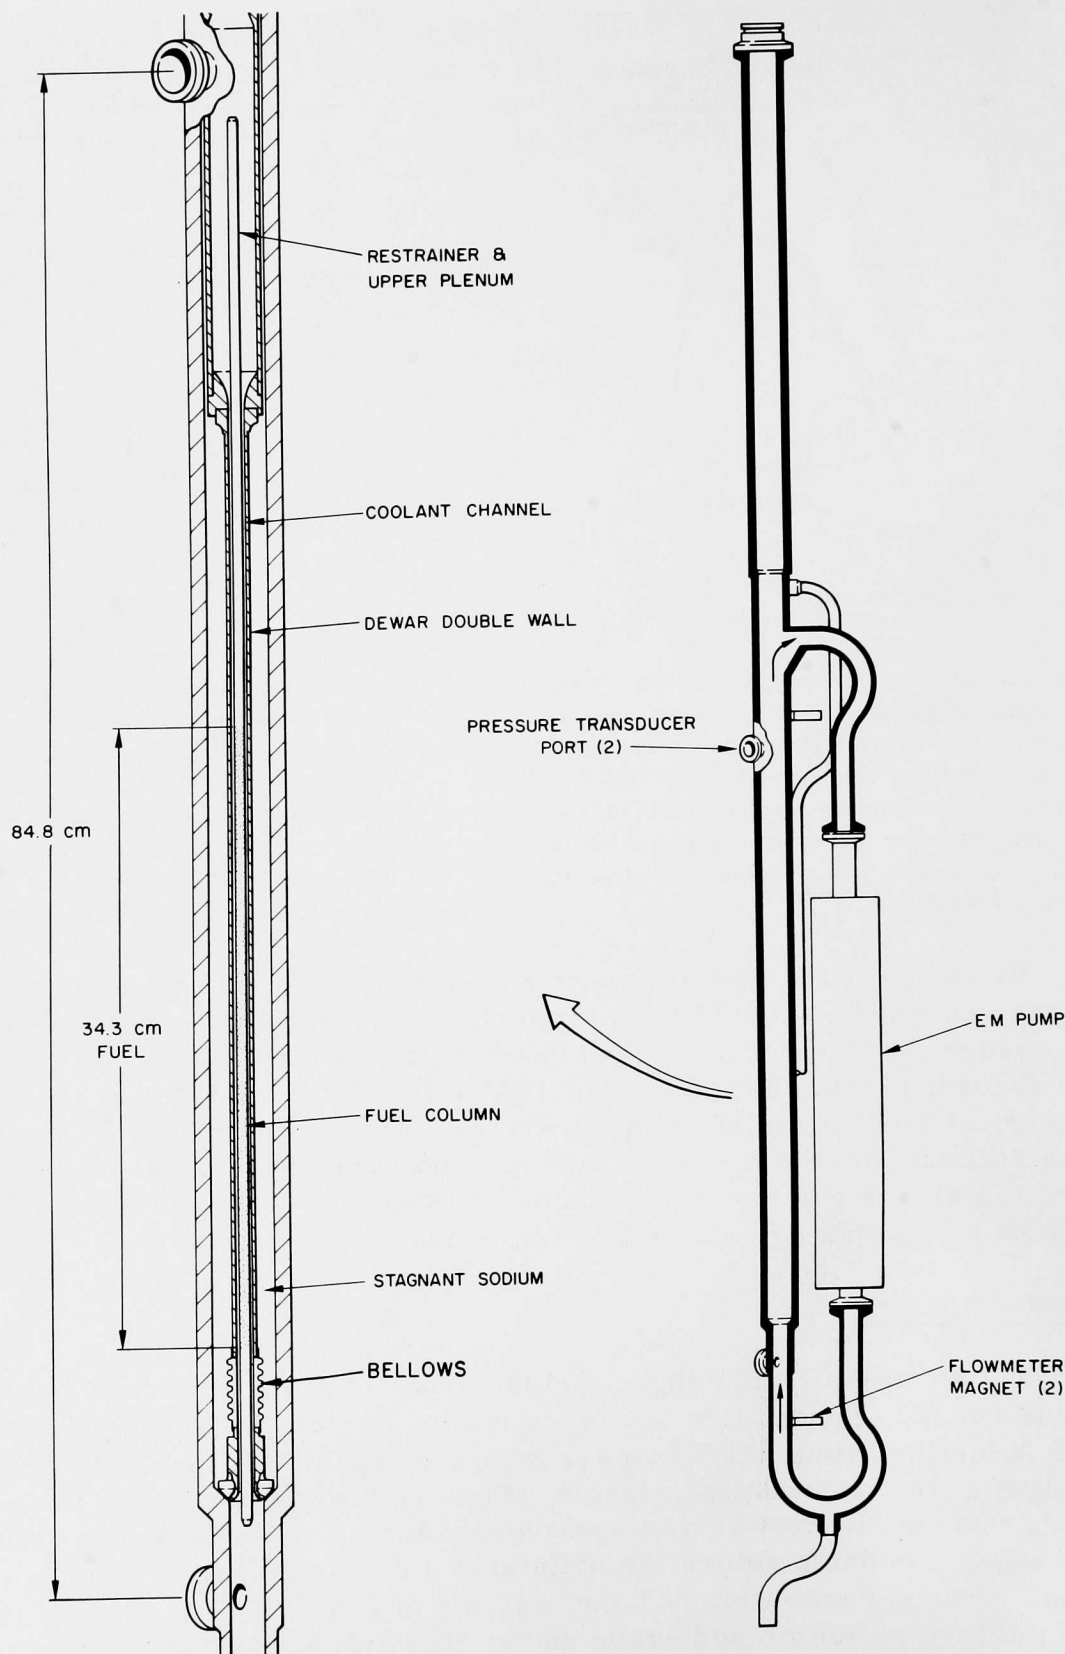
A view of the loop with an exploded view of the fuel pin and holder is shown in Fig. 6. Sodium flow is controlled by an electromagnetic Annular Linear Induction Pump (ALIP) whose pumping capacity is manually or program controlled at the loop control console. Flow is downward through the pump and upwards through the test section and fuel holder. An overflow pipe located 2.5 in. above the pump return leg maintains a constant sodium head in the upper plenum. The approximately 525-cm³ volume of gas above the plenum is filled with a mixture of helium and argon gas at ~0.9 atm at STP and at ~2.1 atm at operating temperature (~800°F). (The fueled test section was loaded into the loop at TREAT under a flowing argon atmosphere. Atmospheric pressure at INEL is ~12.8 psia.)

Fig. 6. Mark-II Loop for TREAT Tests. Sodium flow is upward inside the evacuated double-wall Dewar. The upper flowmeter is just above the upper pressure-transducer port, and the lower pressure port is just above the lower-flowmeter magnet. The restrainer and upper plenum refer to the spacer tube and holdown spring above the fuel pellets within the pin cladding. ANL Neg. No. 900-436.

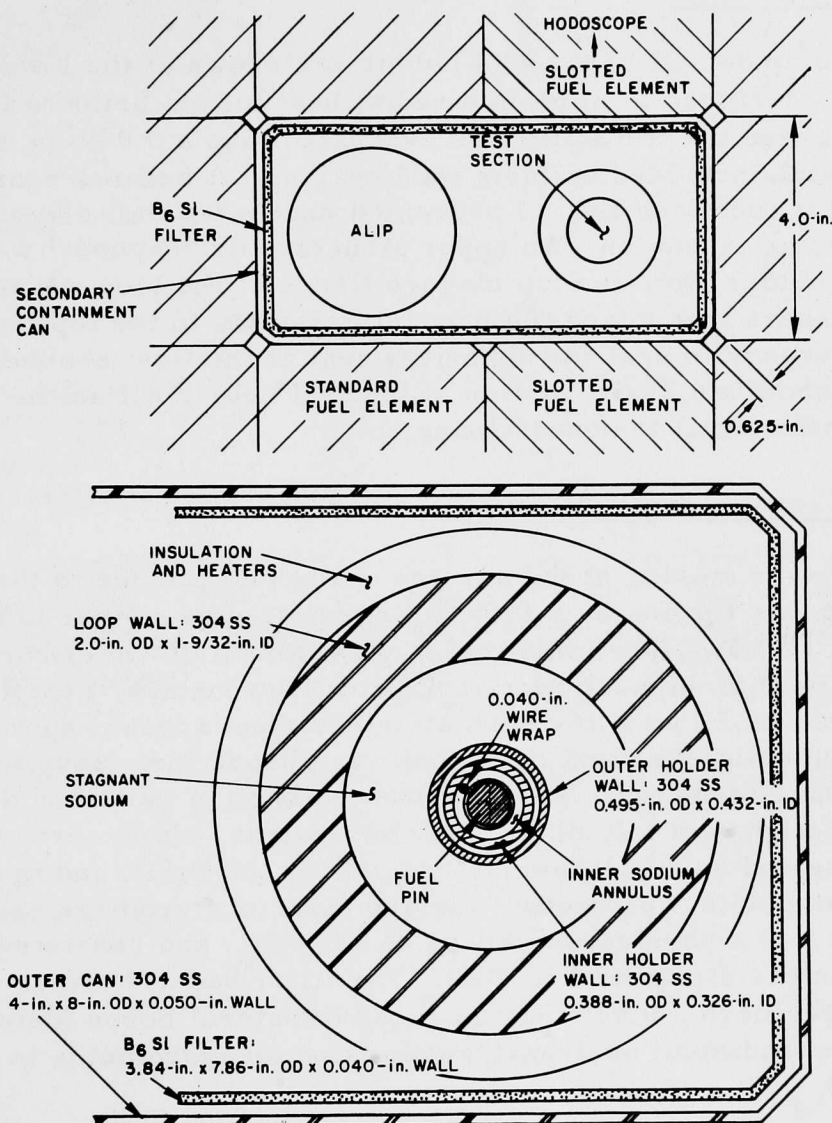
A cross-sectional view of the test at the TREAT midplane is shown in Fig. 7. The upper part of Fig. 7 illustrates the general arrangement of the pump, test section, thermal-neutron filter, and the adjacent TREAT fuel elements. Details of the test section, filters, and secondary containment can are shown in the lower part of Fig. 7. The outer sodium annulus is a region of stagnant sodium.

Fig. 7. Cross Section of Loop in TREAT at Axial Centerline. Top view shows relative locations of the test section, the sodium pump (ALIP), the B_6Si thermal-neutron filter, and the adjacent TREAT fuel elements. Details of the secondary containment can, the filter, and the test-section cross section are shown in the lower figure.

Some details of the fuel holder are shown at the lower part of Fig. 7. It was designed to minimize radial heat losses prior to fuel failure. The space between the two walls was evacuated, and a 0.040-in. spiral wire between the walls provided uniform wall spacing. A bellows near the lower end of the outer tube (see Fig. 6) prevented excessive wall stress due to differential thermal expansion. An upper structure or "bayonet" was used to hang the fuel holder from the top closure flange of the loop. A series of Belleville washers that joined the bayonet assembly to the top flange provided the force necessary to seat the spherical seal at the flow-channel inlet. They also allowed about a 0.25-in. motion of the fuel holder within the loop to accommodate differential thermal expansion.

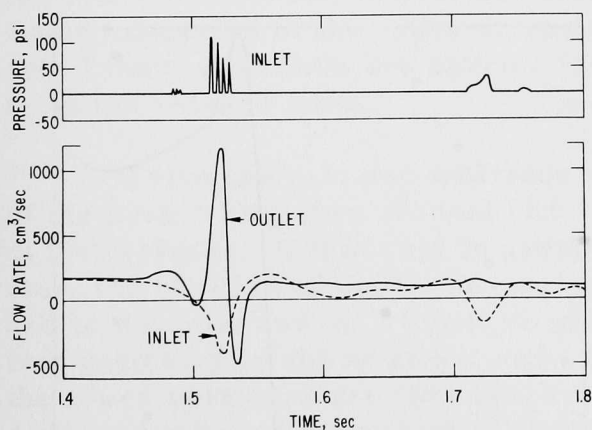
Fig. 9

Figure 9 shows inlet and outlet flow rates (with the 60-Hz signal removed) and lower pressure data (not including the base line shift). Test-section velocity is the volume flow rate divided by the cross-sectional flow area (0.262 cm^2) below TC3 (see Fig. 8). Small apparent differences between inlet and outlet flow up to 1.46 or 1.47 sec may be due to a temperature- and/or radiation-dependent change in upper-flow-detector sensitivity. (Some of this difference results from fuel-pin and coolant expansion due to heating.)

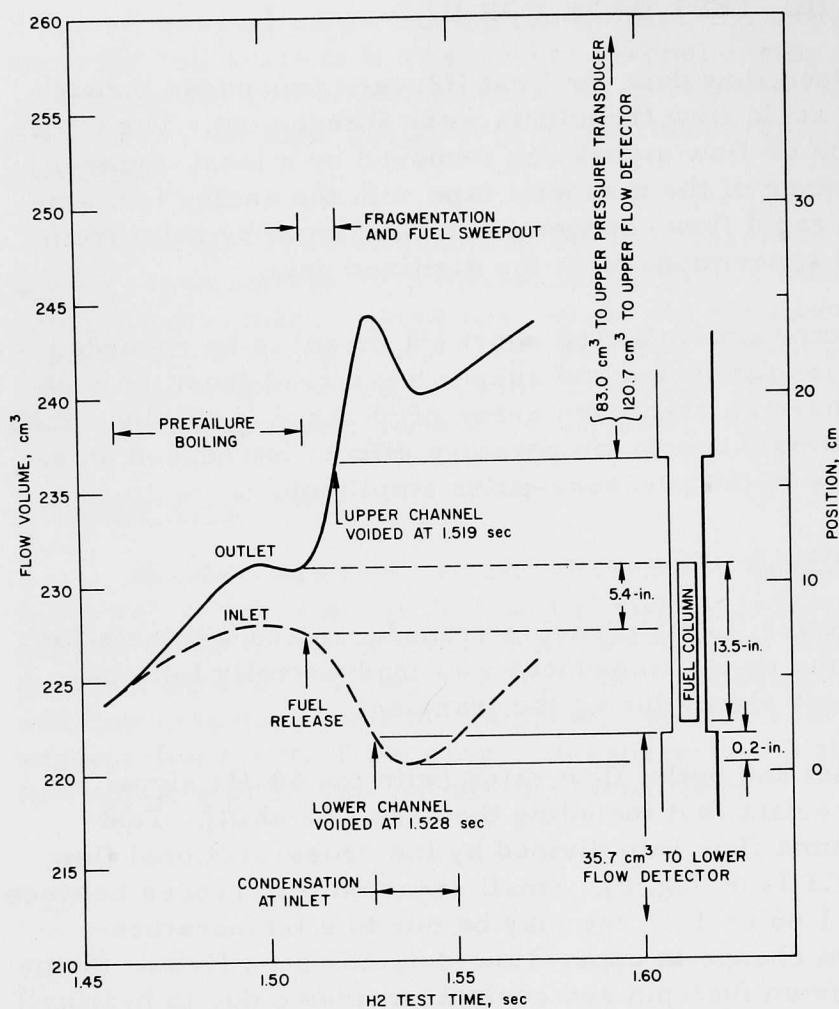
Fig. 10

Figure 10 shows the integrated inlet and outlet flow volumes since zero test time. For a well-defined vapor bubble, the integrated flow is a measure of the position of the liquid-vapor interface with time. Differences between the liquid volumes into and out of the test section constitute the void (see Fig. 11).

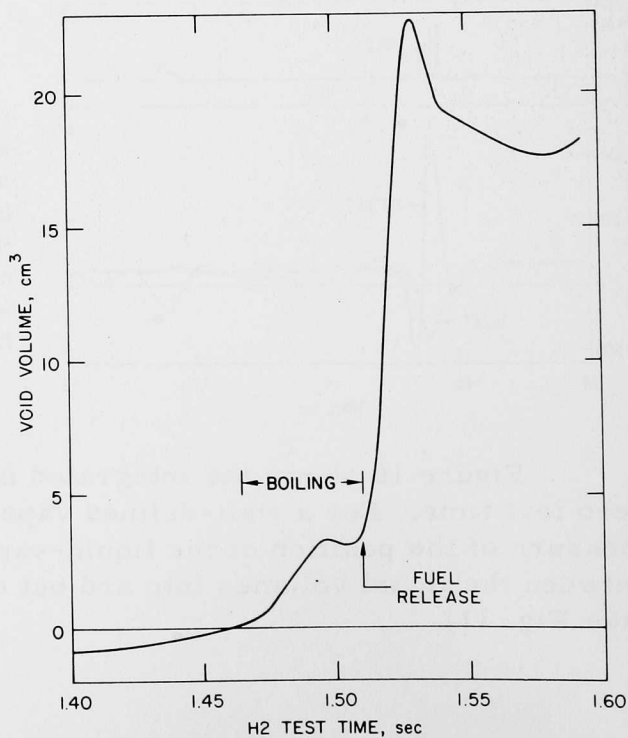
Void-growth Curve. The apparent negative void before boiling begins is a measure of fuel-pin and sodium expansion on heating.

A definite change in the void-growth rate between 1.46 and 1.47 sec is noted in Fig. 11. This is attributed to mild boiling at the cladding surface in the region of the upper insulator pellet and is consistent with the cladding temperatures calculated at 1.465 sec. As the boiling region grew radially and axially, the void grew (see Fig. 11) at an approximately linear rate of $133 \text{ cm}^3/\text{sec}$ from 1.47 to 1.495 sec (that is, for 25 msec). During the period of pre-failure boiling, the flow was two-phase, and the integrated flow volume of Fig. 10 does not represent the mixing-zone interfaces. Differences between the two integrated flow volumes, however, do correctly measure the total void.

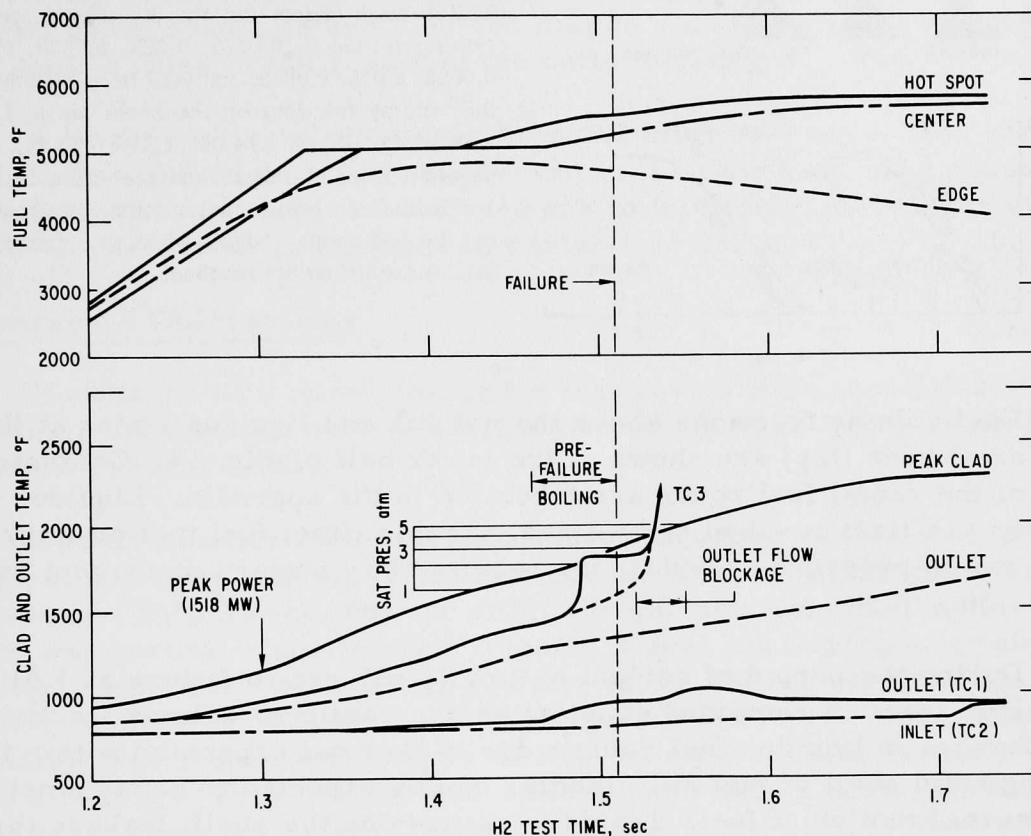
saturation temperature at 1 atm at 1.422 sec and the saturation temperature at 2 atm at 1.483 sec. Observed prefailure boiling began at 1.465 sec, in excellent agreement with the calculation. At this time, calculation indicated that the surface of the fuel pellets began to cool. (This cooling may be over-estimated due to the single-phase heat-transfer model.)

Fig. 13. Calculated (top figure) and Measured (lower figure) Temperature Histories for Test H2. Calculations are reliable up to the time of prefailure boiling and measureable at failure. Peak cladding temperature is for hottest axial node, 1.5 in. below the top of the fuel column. Sodium-saturation temperatures are shown for pressures up to 5 atm.

Calculations shown in Fig. 13 indicate that the rate of thermal-energy addition during the overpower portion of the transient exceeded the heat-energy loss rate by thermal conduction through the fuel pellet and cladding into the sodium flow stream. As melting began near the edge of the pin (at 1.33 sec), the melt front rapidly propagated inward, leaving a thin shell (0.0125 in. thick) on the outside of the fuel pellets. In these calculations, the solidus was defined as the state of the fuel when the melting temperature (5000°F) is first reached, and the liquidus as the state (at the same temperature) after the latent heat of fusion (118 Btu/lb; 247 J/g) has been added. The inward propagation rate of both states is shown in Fig. 14 for a pie-shaped sector of the fuel pellets.

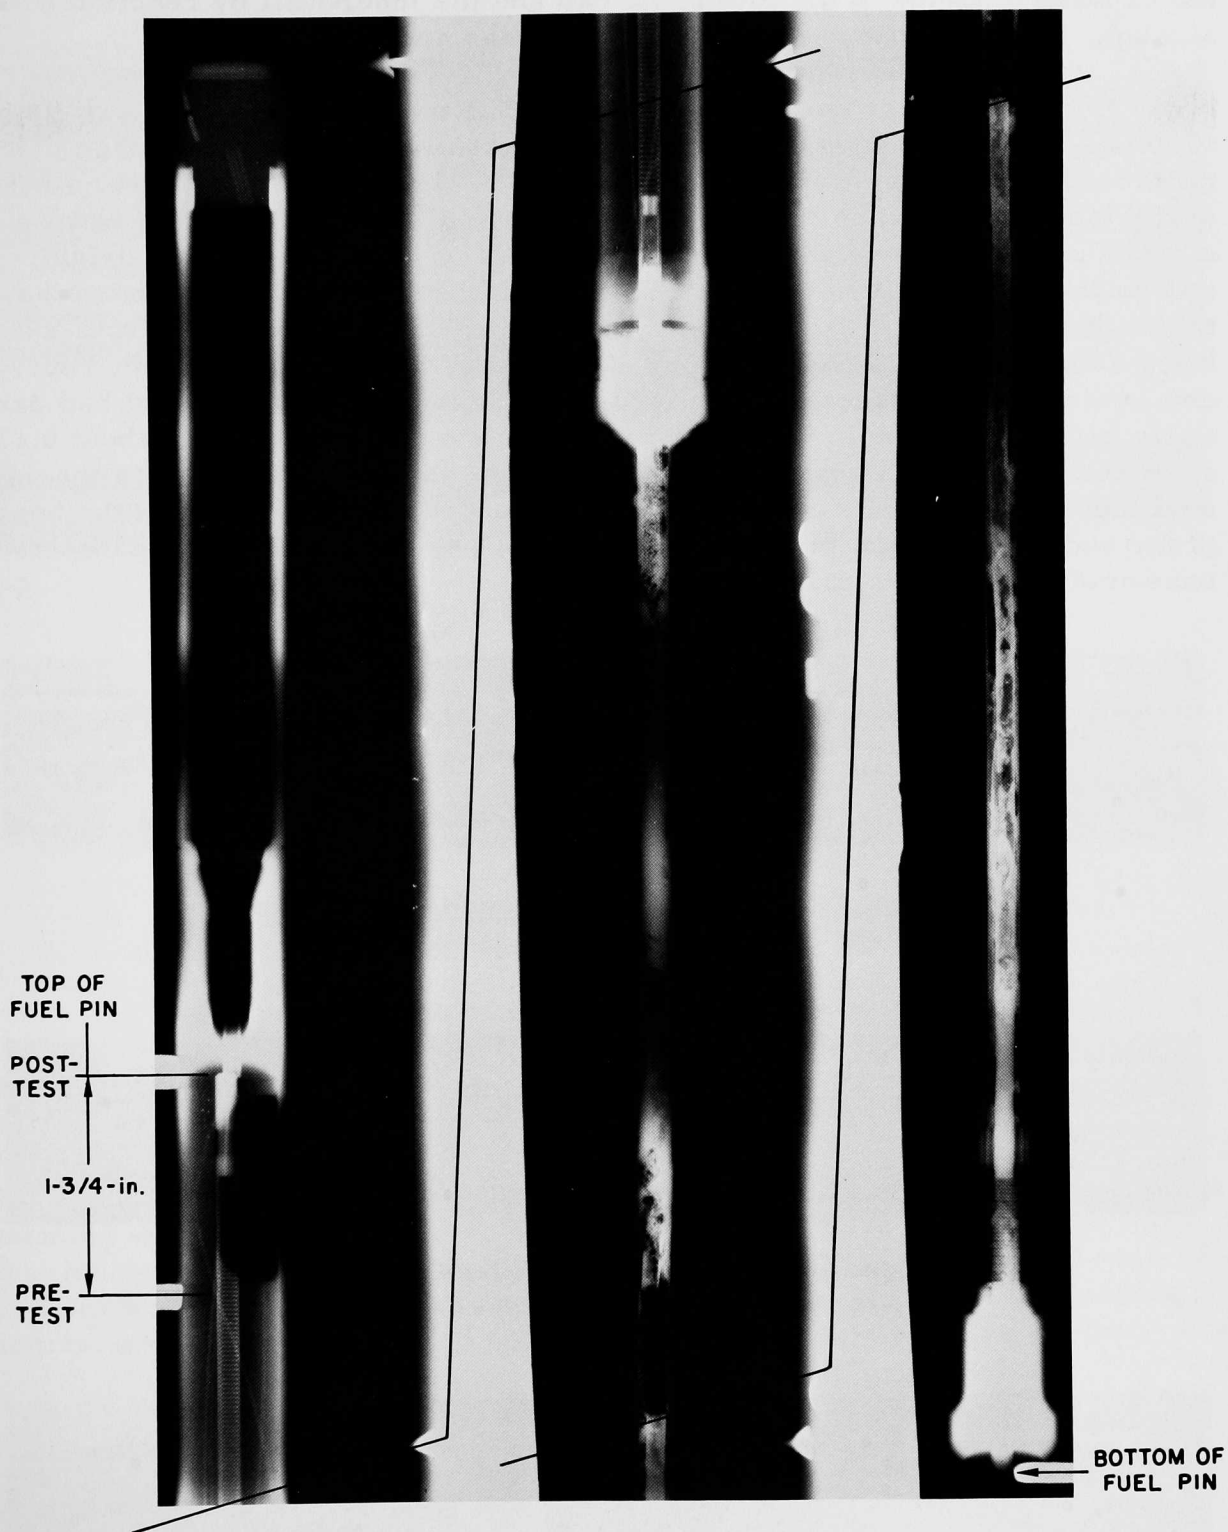
Fig. 16. X-radiograph of Entire Test Section, in Three Portions. Mag. 0.5X. ANL Neg. No. 900-732A.

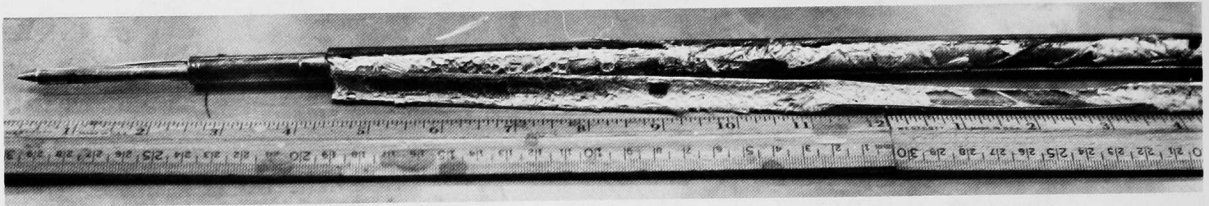
The entire outer wall was then longitudinally slit in two places, $\sim 180^\circ$ apart, using a small, abrasive cutoff machine. One-half was then pried off to expose the inner wall, which is shown in Figs. 17-19. The outer surface of the inner wall and the inner surfaces of the outer-wall segments, when cleaned of sodium by reaction with alcohol, were found to be clean, bright, and relatively straight, except for two areas. The first was adjacent to the top of the original fuel column, which was located about 17.375 in. from the bottom of the rod. As shown in Fig. 20, several holes had been burned out and several short cracks were in evidence. Some once-molten steel had partially filled the region between the separator-wire convolutions at about 0.17 in. from the bottom of the rod. A small amount of debris was evident on the adjacent inner surfaces of the outer wall. The second area, ~ 8 in. from the bottom of the rod, was a small blister ~ 0.5 in. long. The area probably represents once-molten stainless steel.

Fig. 17. Exposed Portion of Lower Section of Inner Wall after Longitudinally Slitting Outer Wall. ANL Neg. No. 900-1156.

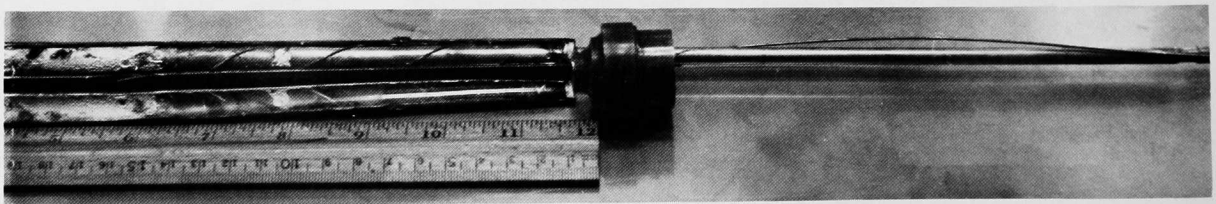
Fig. 19. Exposed Portion of Upper Section of Inner Wall after Longitudinally Slitting Outer Wall. ANL Neg. No. 900-1158.

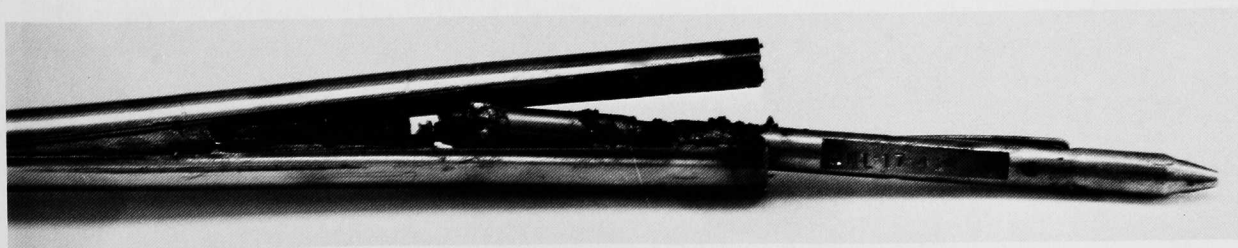
The entire length of the inner wall was next slit longitudinally in two places, $\sim 180^\circ$ apart. The lower end was pried up and the lower end plug was found to be easily removable, as seen in Fig. 21. Loose and adherent debris were found, along with once-molten cladding that had dropped down from the region immediately above. The latter is more clearly seen in Fig. 22. The lower 4.75 in. of one of the slit halves were cut off transversely. The remaining section was slit a little deeper to open the halves of the inner wall. One inner surface is shown in Figs. 22 and 23. An enlarged internal view of this surface in the interaction zone is shown in Fig. 24. Fuel and cladding debris, as well as the charred upper portion of the element, are evident. Fuel

Fig. 21. Slit Inner Wall, Showing Free Lower End Plug. Mag. 0.975X. ANL Neg. No. 900-1171.

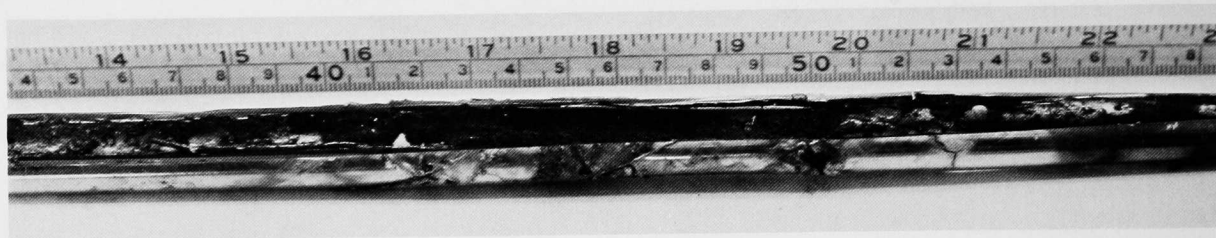
Fig. 24. Enlarged View of Inner Wall at Interaction Zone. ANL Neg. No. 900-1178.

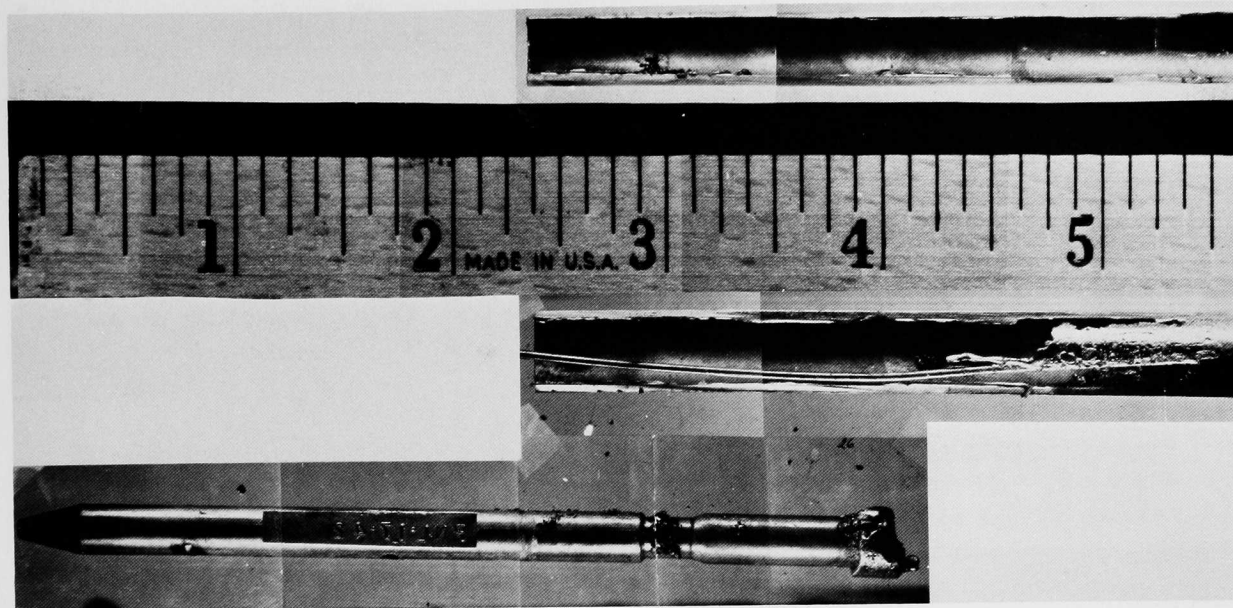
Fig. 25. Inside Surfaces of Inner Wall, 0-5 in. from Bottom End Plug. Neg. No. MSD-168134.

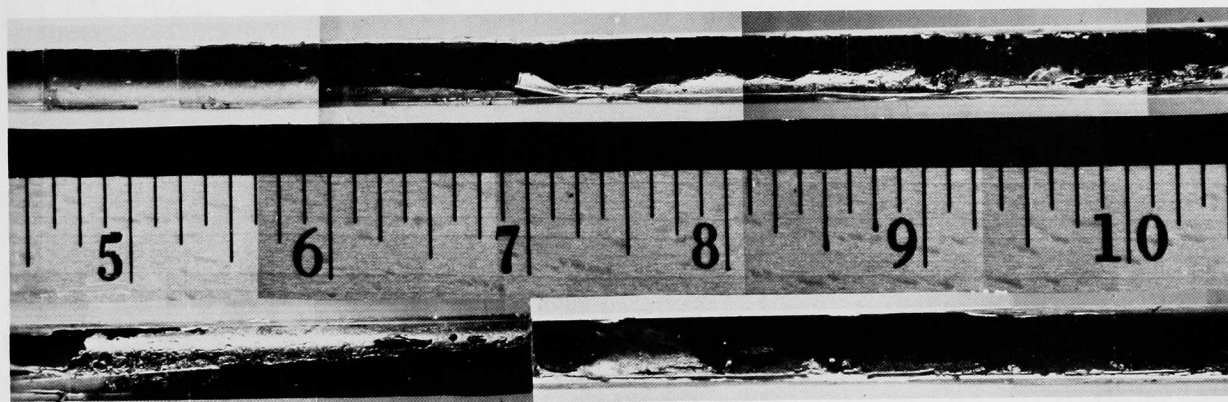
Fig. 26. Inside Surfaces of Inner Wall, 5-10 in. from Bottom End Plug. Neg. No. MSD-168135.

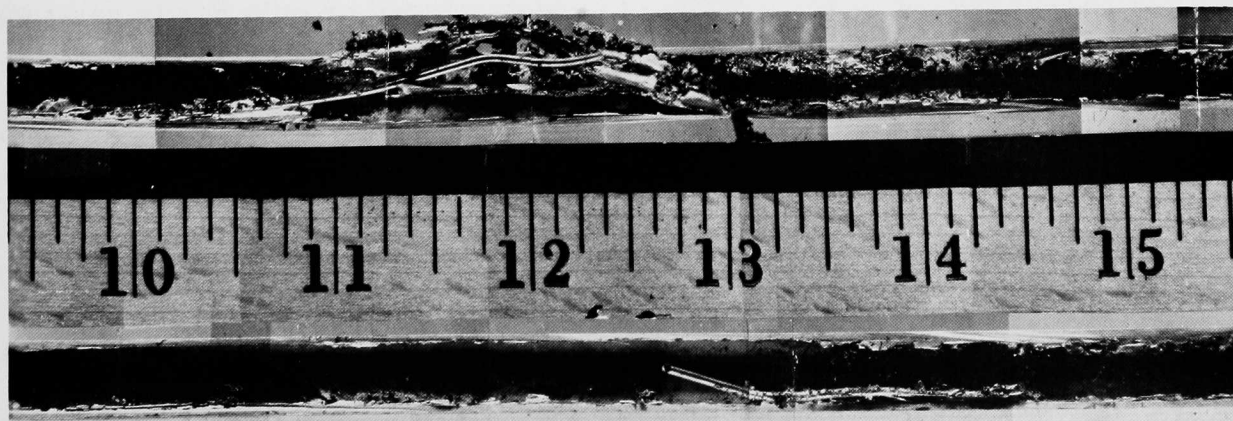
Fig. 27. Inside Surfaces of Inner Wall, 10-15 in. from Bottom End Plug. Neg. No. MSD-168136.

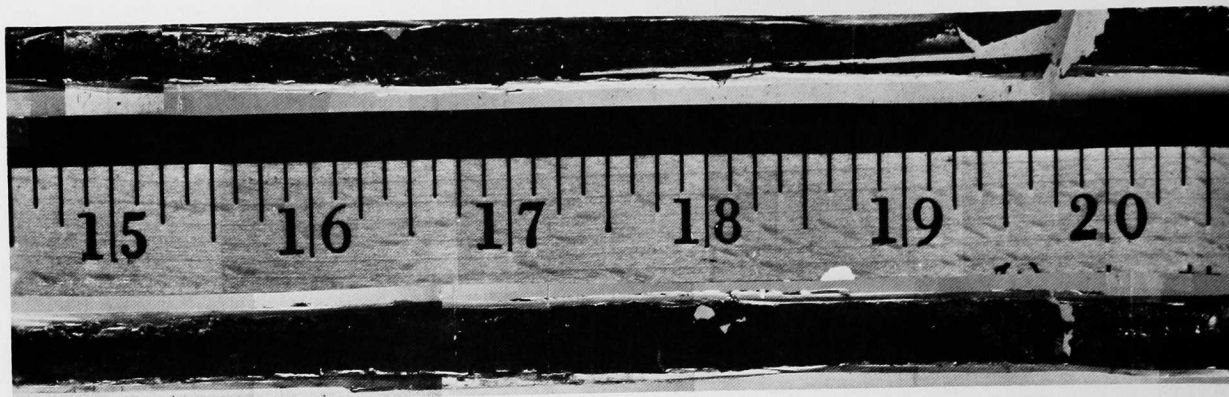
Fig. 28. Inside Surfaces of Inner Wall, 15-20 in. from Bottom End Plug. Neg. No. MSD-168137.

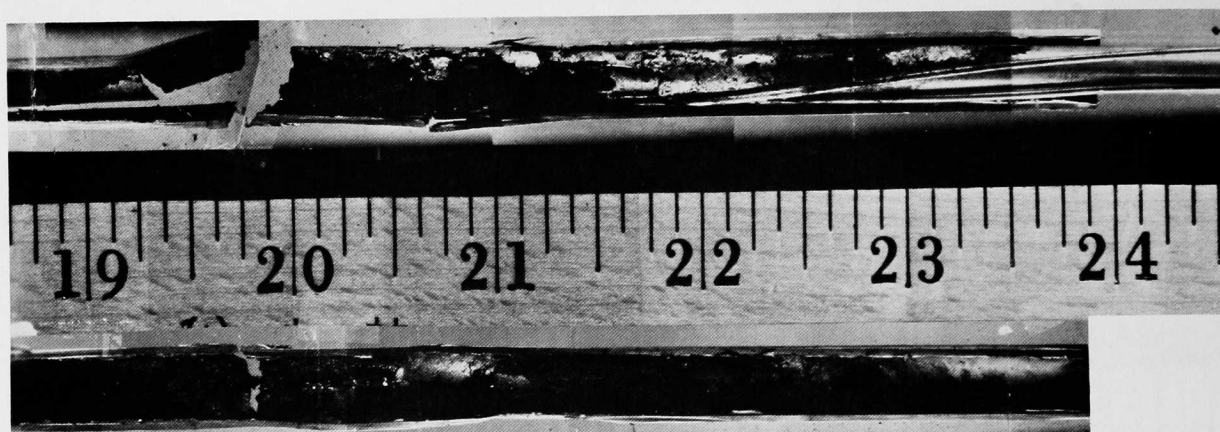
Fig. 29. Inside Surfaces of Inner Wall, 19-24 in. from Bottom End Plug. Neg. No. MSD-168138.

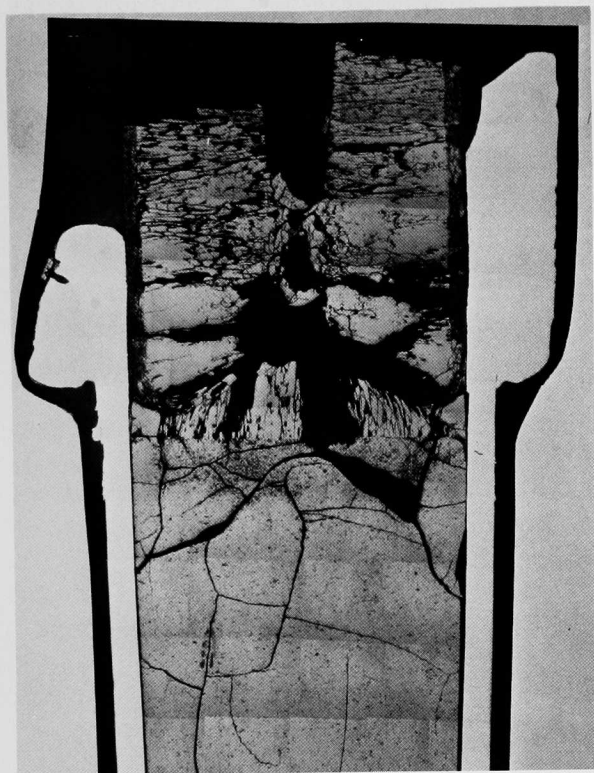
interface was about 3.875 in. from the bottom of the rod. The bottom of the fuel column is shown in Fig. 30. Fusion had occurred (within the cladding) between the resolidified fuel and the UO_2 insulator pellet almost across the entire interface. In the region of the junction of the cladding, fuel, and insulator pellet, the fuel appeared to have molten. Directly above the region of the juncture, a 9-12-mil-thick layer of unrestructured or only partly restruc-tured fuel occurred. The fuel at the juncture of fuel, insulator pellet, and cladding appeared to have been hotter (approximately at the solidus) than the fuel directly above it. The layer of unrestructured fuel against the cladding is similar to that observed in Test E2. The pattern of columnar grains is indicative of the solidification pattern, and at the top of the photograph is what appears to be the bottom of a central void in the columnar grains of fuel. The insulator pellet experienced grain growth to an average depth of ~30 mils, increasing slightly toward the center. The stainless steel that flowed down and froze appeared (see Fig. 22) to have blocked ~60% of the channel over an axial distance of 0.1-0.2 in. Dispersed fuel and cladding par-ticles from above could temporarily bridge this gap to cause a flow blockage.

Fig. 30. Fuel and Insulator Pellet at Bottom of Fuel Column. Mag. 7.75X. Neg. No. MSD-161691.

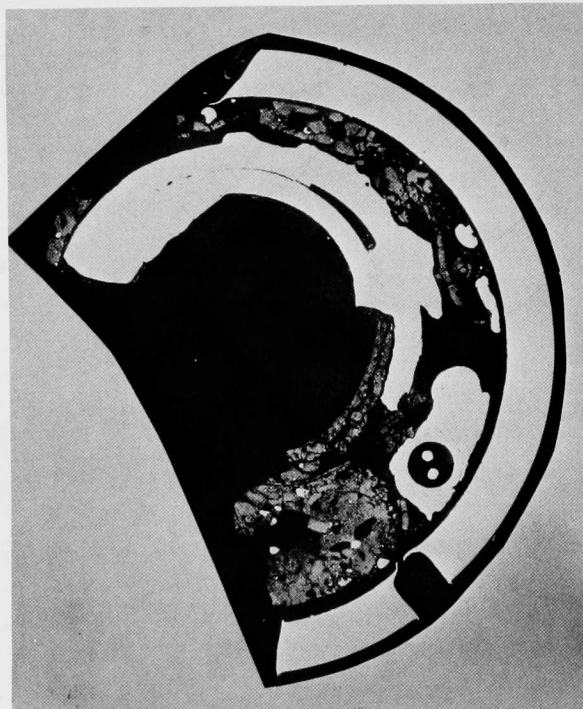
Fig. 37. Transverse Section of Inner Wall at ~18.5 in. from Bottom of Rod. Mag. 7.5X. Neg. No. MSD-161694.

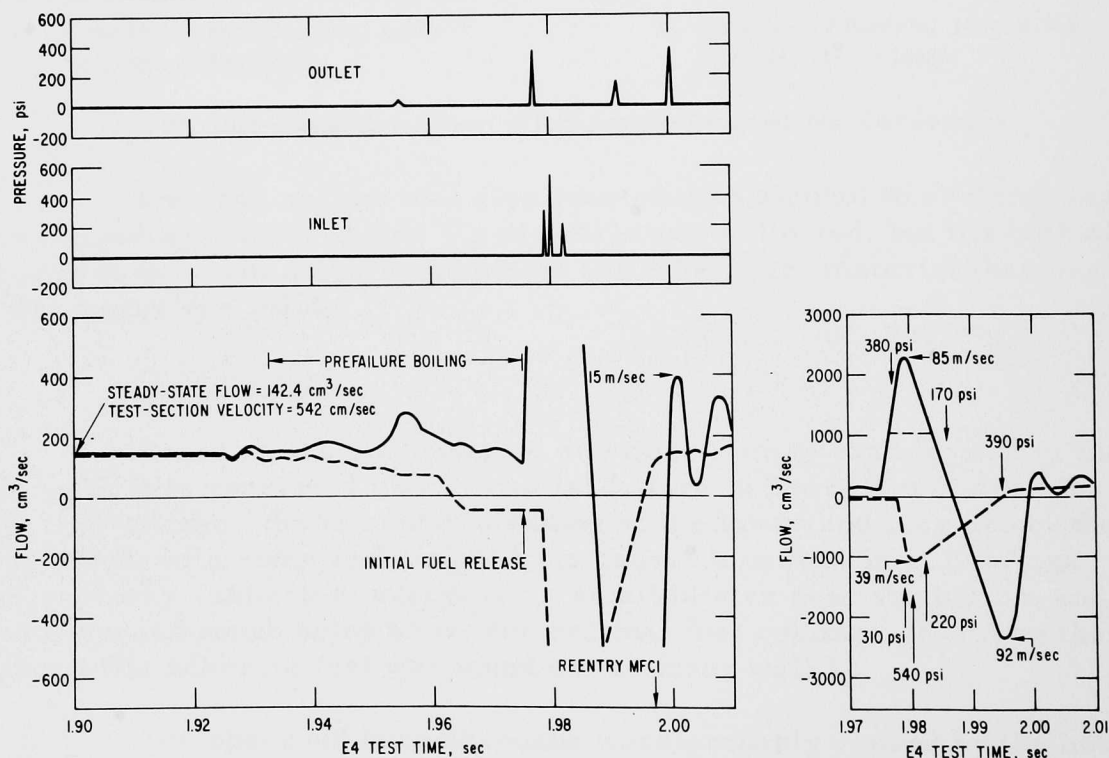
Fig. 40. Prefailure Flow and Pressure Data for Test E4. Steady-state flow at 1.90 sec is $142 \text{ cm}^3/\text{sec}$. The initial slug ejections are shown to the right on a compressed amplitude scale; the timing and amplitudes of inlet (bottom) and outlet (top) pressure pulses are shown with arrows. Detector saturation levels during initial slug ejection and reentry are shown by horizontal dashed lines. The zero shift in pressure-transducer baseline has been removed.

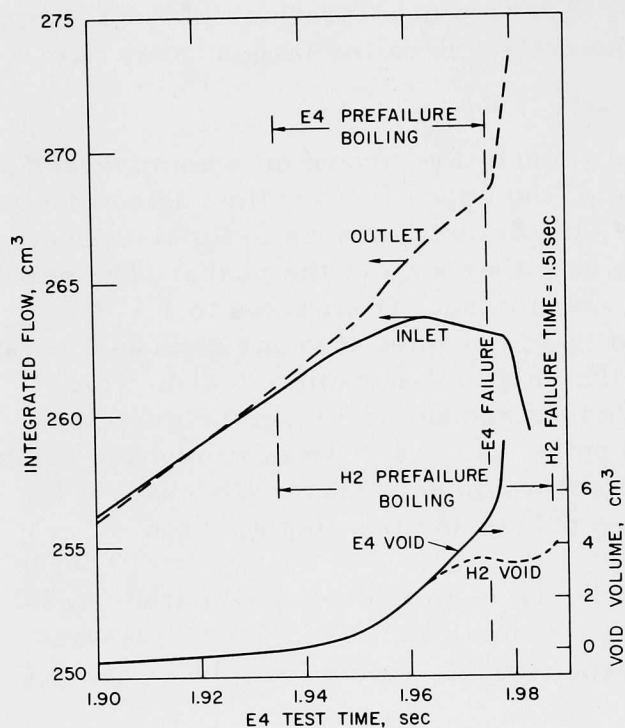
Fig. 41. Prefailure Integrated Flow and Void Volume for Test E4. H2 void data are shown for comparison.

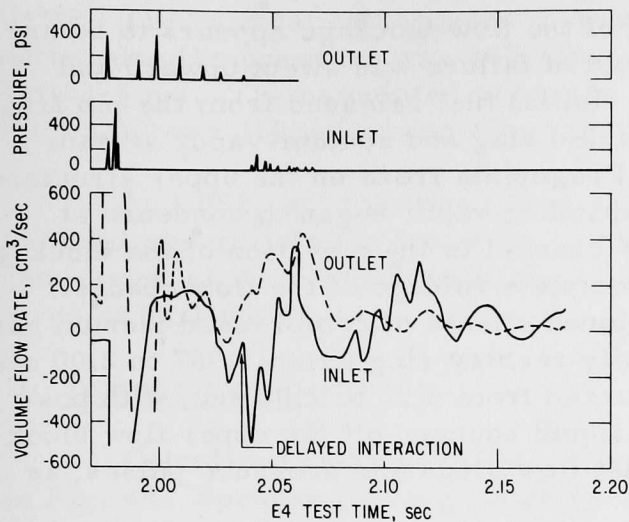
Fig. 42. Postfailure Flow and Pressure Data for Test E4. Details of the initial slug ejection after failure are shown in Fig. 40.

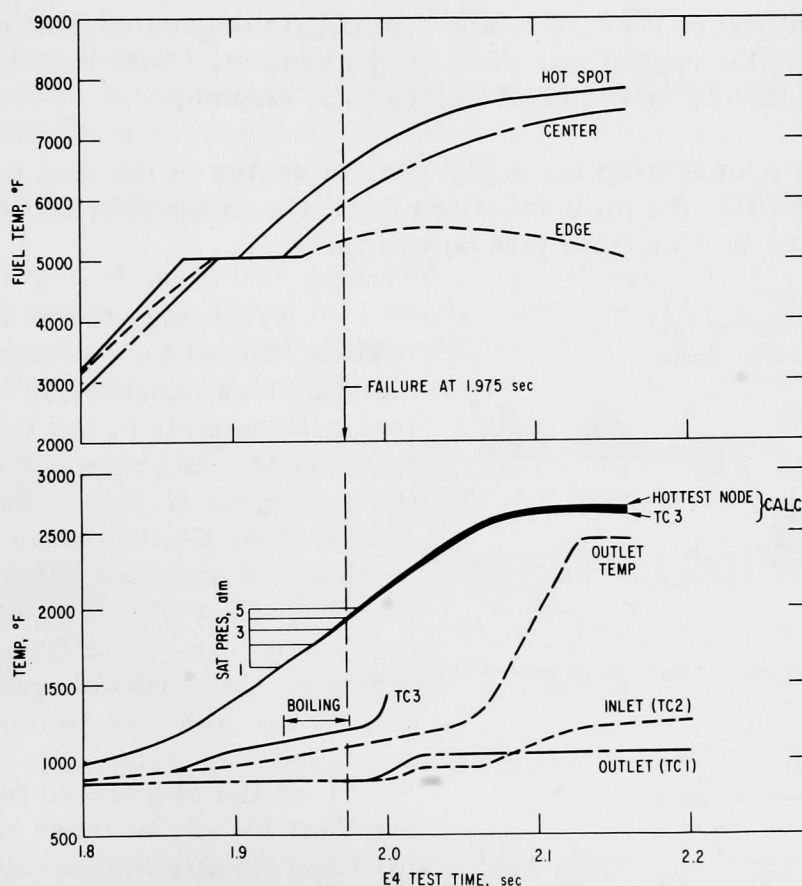
Fig. 45. Temperature Histories for Test E4. Top curves show calculated temperature at the edge, the center, and second radial nodes in from the edge (hot spot) of the fuel pin at the hottest (top) axial node. Cladding (calculated) and coolant (calculated and measured) temperatures are shown in the lower curves.

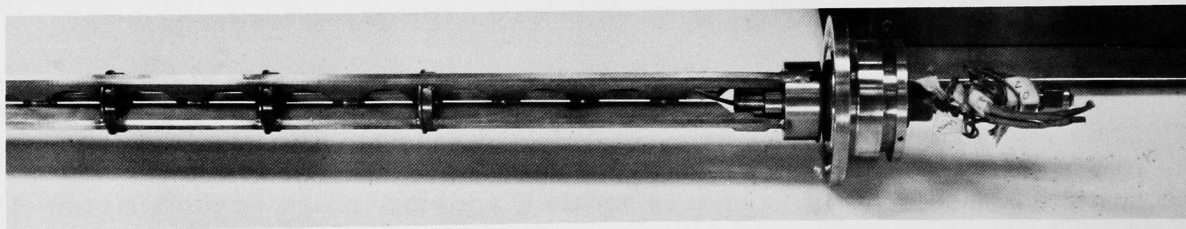
Fig. 51. Test Train Showing Bayonet Assembly and Upper Housing. Mag. 0.3X. ANL Neg. No. 103-A12323.

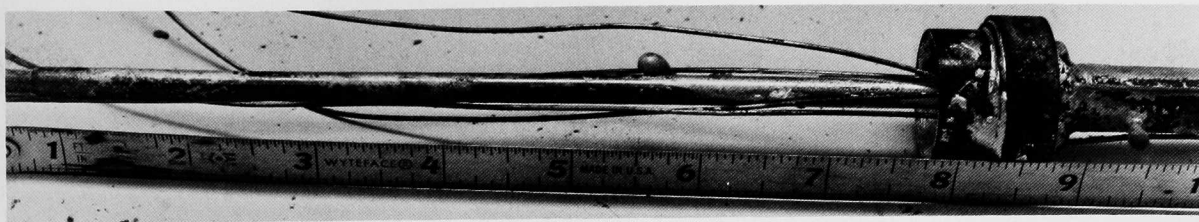
Fig. 52. Fuel Element above Fuel Holder after Removal of Adapter Tube. ANL Neg. No. 103-A12364.

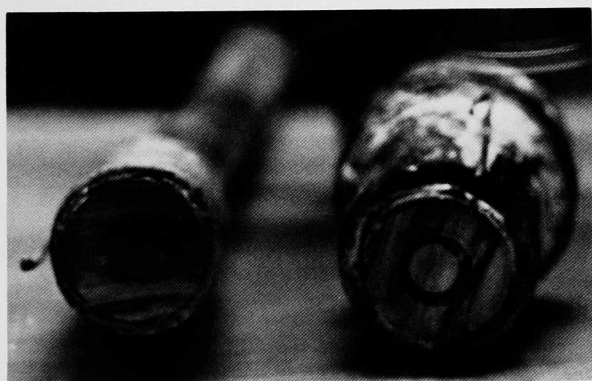
Fig. 53. Surfaces Exposed after Transverse Cut below Bellows. ANL Neg. No. 103-A12361.

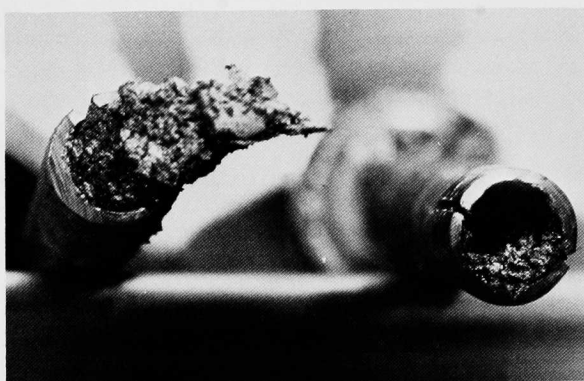
Fig. 54. Surfaces Exposed after Transverse Cut above Top of Fuel Column. ANL Neg. No. 103-A12363.

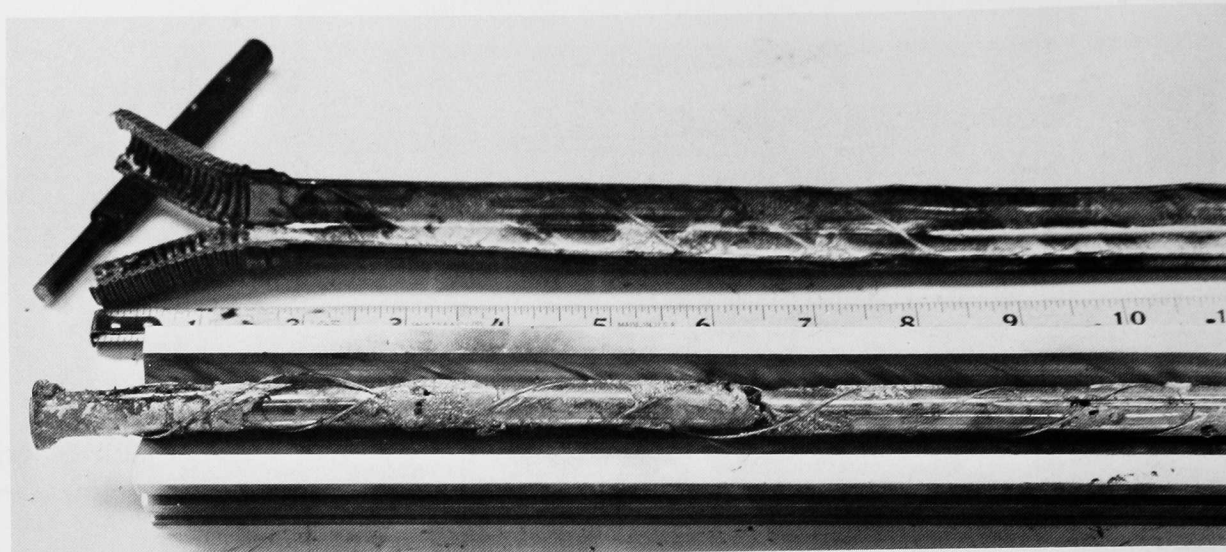
Fig. 55. Lower Portion of Inner Wall after Removal of Outer Wall. ANL Neg. No. 103-A12357.

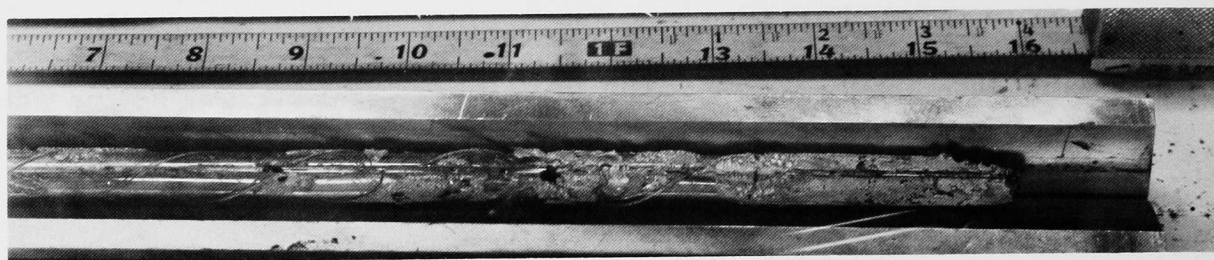
Fig. 56. Middle Portion of Inner Wall after Removal of Outer Wall. ANL Neg. No. 103-A12356.

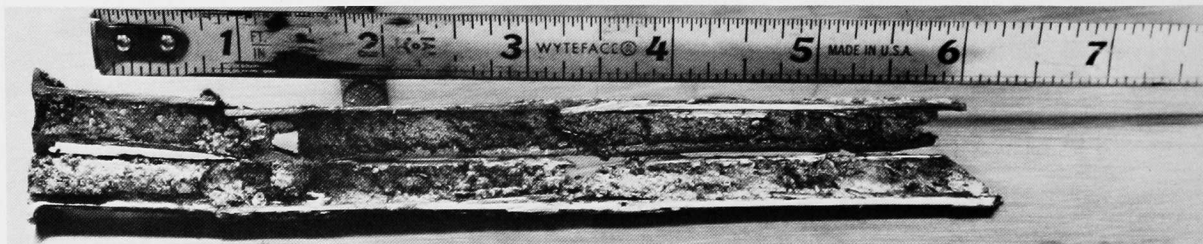
Fig. 57. Bottom Portion of Inner Wall after Slitting. ANL Neg. No. 103-A12349.

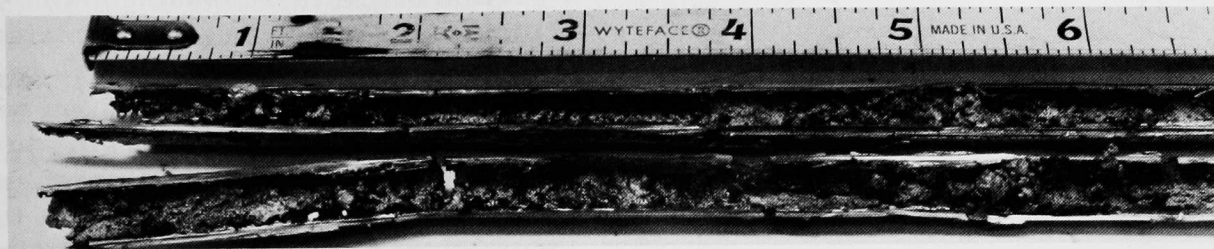
Fig. 58. Upper Part of Middle Portion of Inner Wall after Slitting. ANL Neg. No. 103-A12343.

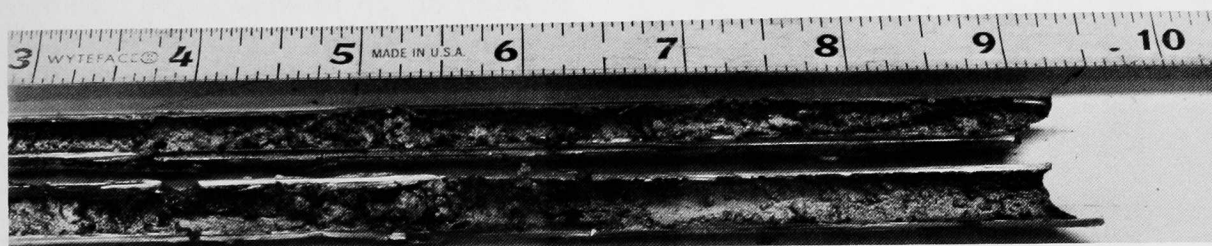
Fig. 59. Lower Part of Middle Portion of Inner Wall after Slitting. ANL Neg. No. 103-A12344.
